# FATIGUE BEHAVIOUR OF A ROLLED AZ31 MAGNESIUM ALLOYS PREPARED BY EP AND BB CONDITIONS

**Abstract:** Rotating bending fatigue tests have been performed using smooth specimens of a rolled AZ31 magnesium alloy in laboratory air at ambient temperature. Fatigue strength and characteristic was evaluated and fracture mechanism was discussed on the basis fracture surface analysis. Electrical polishing (EP) as well as deep rolling (ball burnishing (BB)) U-notched specimens were performed on two groups of samples, to evaluate optimum conditions for fatigue life. The microstructure and tensile properties of roll cast (RC) Mg- 3% Al- 1% Zn (AZ31) was investigated. The fatigue strength of 107 cycles around 100 MPa for deep rolling while it was around 40 MPa for Electrical polishing. It was very important to understand the effect of (ball burnishing (BB)) conditions on the hardness of the surface through to the core. The two procedures improved the fatigue performance, but better improve in results were found in ball burnishing. The growth of small cracks initiated at the surface coincided with the FCP characteristic after allowing for crack closure for large cracks, but the operative fracture

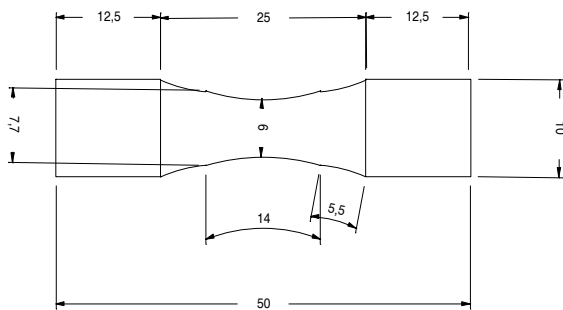
As shown in Fig. 1. Mechanical testing tensile and fatigue specimens with 5 mm diameter, 14 mm gauge length was machined from as-received so that their axis is parallel to the rolling direction. BB condition prepared with the following preparation condition on ECOROLL instrument using tool type (HG6) at 100 bar (246 N) with feed rate of 0.17 mm/min at 30 rpm.

**Fig. 1.** Shape and dimension of mechanical testing specimens

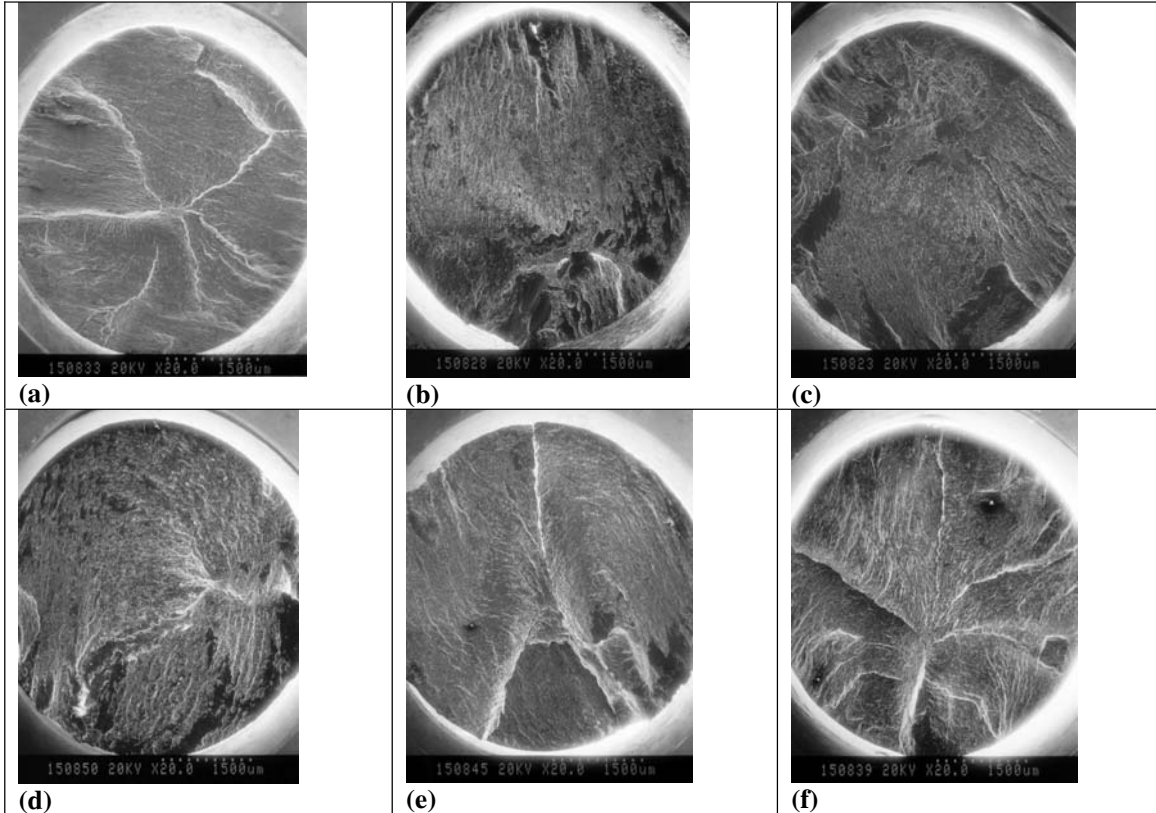
The fracture surface of AZ31 for EP condition and BB condition at different stress is shown in Fig.

4. Subsurface crack initiation occurred at applied stresses at 60 MPa. At BB condition but it can be seen for both 80 and 100 MPa stress for EP condition. The S-N diagram is shown in Fig. 2. It is well known that fatigue limit does not exist in non-ferrous alloys, thus fatigue tests were continued until  $10^7$  cycles. At EP condition  $\sigma = 40$  MPa, fatigue failure did not occur, but non-propagating cracks were observed on the specimen surface. As can be seen in the figure, the present Mg alloy seems to possess a definite fatigue limit, which may be related to the existence of non-propagating cracks. The fracture mode depending

**Fig.4.** SEM micrographs showing fracture surfaces at difference stress for EP at (a) 60MPa; (b) 80 MPa; (c) 100 MPa and BB at (d) 60MPa; (e) 80 MPa; (f) 100 MPa.

on applied stress level, above 60 MPa cracks initiate at the surface (surface fracture), while below that stress at the interior of the specimen (subsurface fracture). Subsurface fracture is a very interesting finding, which has not been recognized in Mg alloys, for both EP and BB conditions.

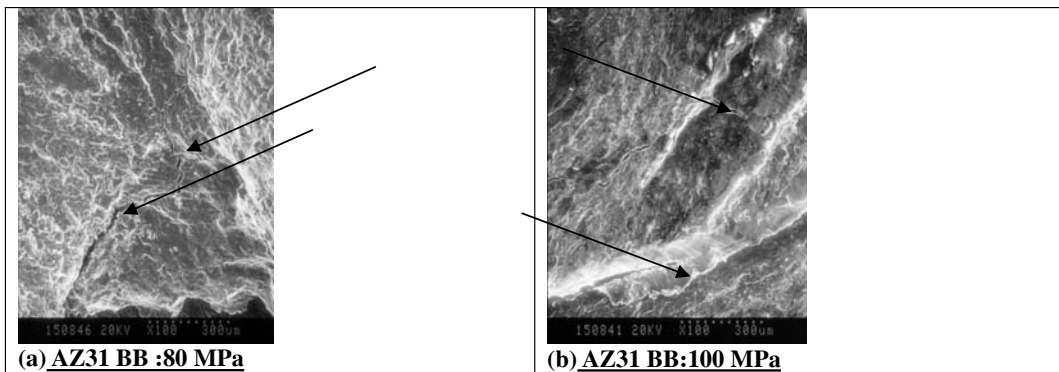
**Fig. 5.** SEM micrographs showing cracked surfaces at difference stress for BB at (a) 80MPa; (b) 100 MPa

The cracked line could be seen easily for higher stress for BB condition as fracture occurs in internal surface not at the outer surface as in the EP condition in Fig. 5.
